Rule 26 Report

This report is for the residents at 16207 E. 47th Place, Tulsa, OK 74134. I have prepared a replacement cost estimate for the roof and exterior of this home. I was also asked to review the existing documentation and other written reports that addressed this home and provide my opinions on them.

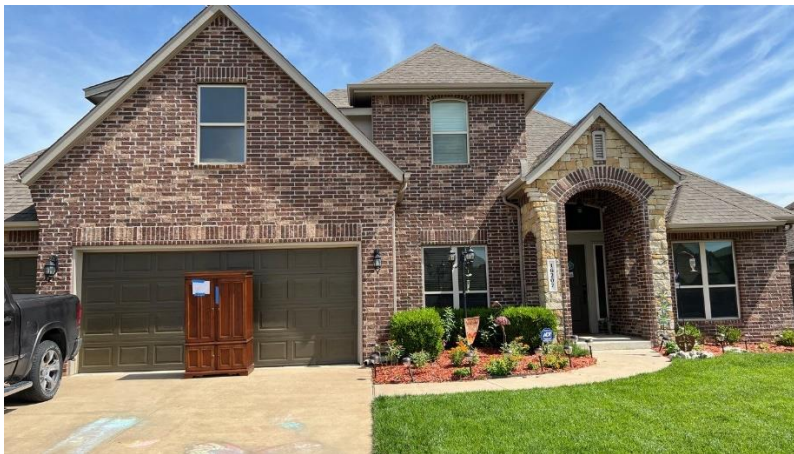
The Bales Family's home is a single-family home in Subdivision Trinity Creek II addition. The home was built in approximately 2010. The home has a laminated composition shingle roof which was approximately 12 years old at the time of the Bales Family's claim with State Farm Insurance. Based on a conversation I had with the Bales Family, it is my understanding they purchased the home in late 2020. Prior to their purchase of the home, they had an inspection performed and no wind or hail damage was noted to any areas of the roof. Below is a photograph of the front of the Bales Family's home:

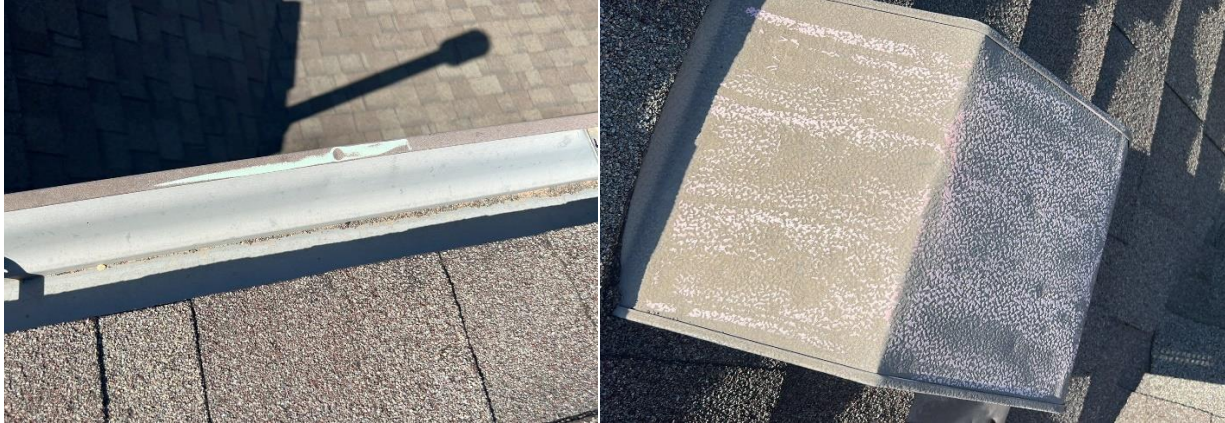
I also accessed the Bales Family's roof via a ladder, Goat, and pitch hoppers to inspect the roof surface. This included chalking of the soft metals for evidence of hail damage in the manner outlined above. This process found several dents that were indicative of hail damage to the Bales Family's soft metals. Some representative photographs of hail damage found to the valleys and soft metals include:

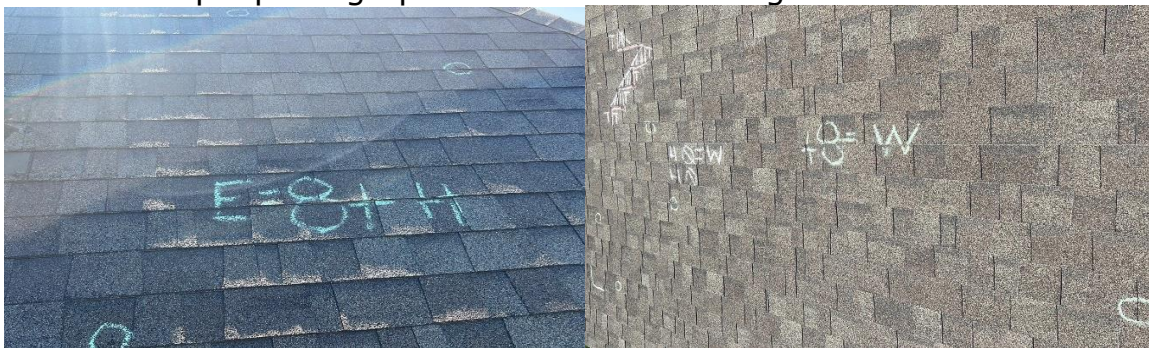
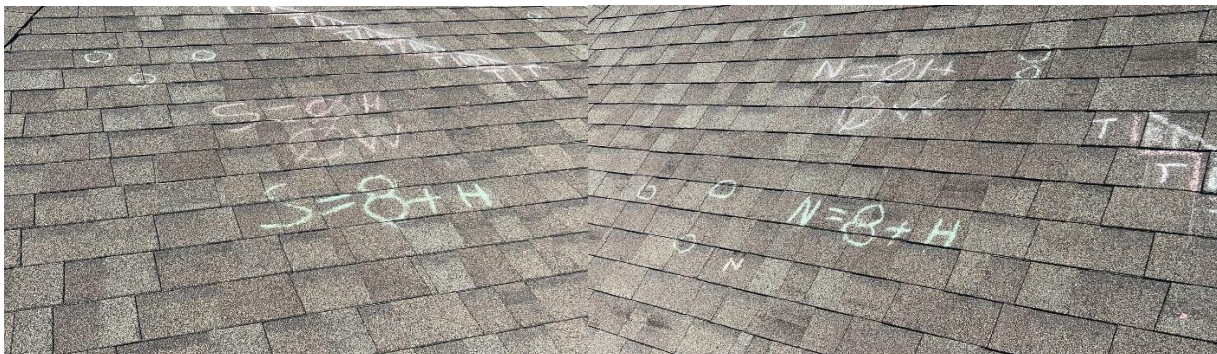
During my inspection of the Bales Family's home, I observed extensive storm damage to the laminated composition shingles and roof surfaces consistent with the descriptions of wind and hail damage described above. Specifically, I performed test squares on each of the slopes to mark and test for hail and wind damage. Within these test squares, I observed bruising, punctures and fractures in the laminated composition shingles indicative of hail damage. I also felt the bruising and dents to the laminated composition shingles to confirm. I also observed lifted shingles indicative of wind damage. There is a tarp covering wind damaged shingles on the lower west hip. I observed additional wind damaged shingles on the upper west slope of the roof. Within each of the test squares I performed, I found 8+ hail hits and/or wind damage. Per roofing and insurance standards, this requires the slopes to be replaced. Some example photographs of the storm damage found include:

Based on my observations described above, it is my opinion the roof surface damage outlined above is associated with wind and hail from the storm in question. The entire roof will need to be replaced.
